## Low PIM Solutions: Threaded Rod Adapters and Insulators

## APPLICATION NOTE

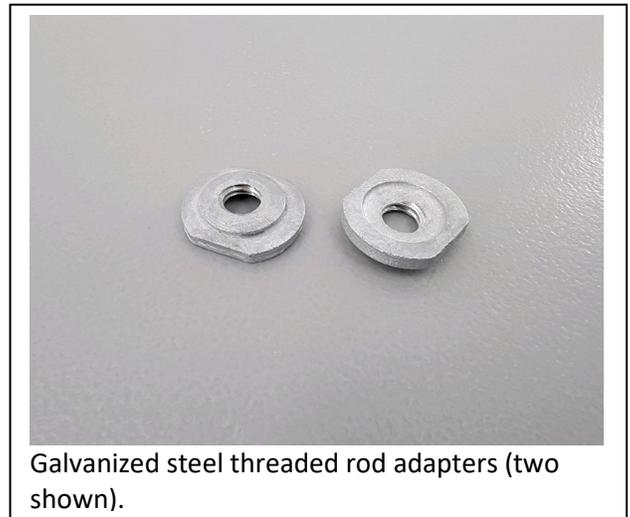
ConcealFab has developed low PIM solutions for adapting threaded rods with cable blocks to the holes of cable support bars, originally intended for snap-in style cable hangers. The galvanized threaded rod adapter was designed to secure 3/8" galvanized threaded rods to cable support bars with 3/4" diameter snap-in mounting holes. The adapter ensures solid metal-on-metal contact when torqued to the proper specification ([10 ft-lbs, ConcealFab tool 900053](#)). The size of the adapter also accounts for potential galvanization build-up in the snap-in holes.

Galvanized steel threaded rod adapters (two shown).

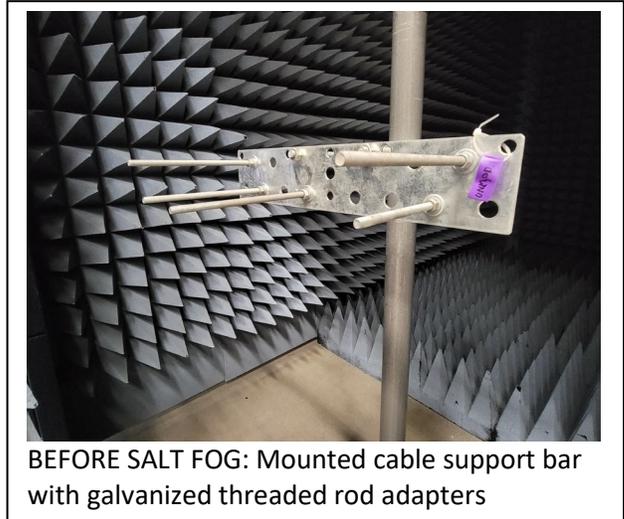
In addition to the standard PIM-testing required for qualifying low-PIM product, ConcealFab has also performed salt-fog testing (done to specification ASTM B117) to simulate the impact of outdoor exposure on PIM performance of the galvanized adapters. It is known that galvanized steel assemblies, while considered robust for the outdoor environment, can eventually corrode over time leading to intermodulation products when exposed to RF energy. To address this concern, a fully mounted cable support bar assembly with five galvanized threaded rod adapters and threaded rods kits were exposed to salt-spray for 168 hours and PIM-tested before and after. Before salt spray, the assembly passed radiated PIM-testing in both 1900 (PCS) and 700-band (data not shown).

After salt-spray exposure, the assembly was gently rinsed, dried, and re-mounted to the support stand and PIM-tested again to IEC 62037-8. Under dynamic stimulus, the peak IM3 generated from the assembly was less than -100 dBm at all tested transmitted signal polarizations and product orientations—a passing result.
